# Noise from Scan Fish fasteners

Effect of metal located near magnetic sensors  
on magnetic field recordings

Rev. 1.1

R.V. GeoRanger  
07.04.2024

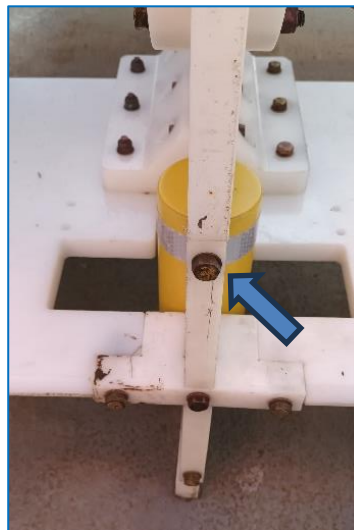
Thus, *the appearance of VG\_prh-anomalies was found to be caused by sets of mounting bolts located in close proximity to the magnetic sensor (Figure 1.3).*

*Figure 1.3* Positioning the Scan Fish mounting bolts close to the magnetic sensor

The most radical method of dealing with VG\_prh-anomalies particularly noise from metal near the magnetic field sensors, is to change the frame design by removing the metal fasteners from the magnetic sensors or replacing those fasteners with the plastic ones.

As can be seen from the above, bolts installed in close proximity to the magnetic sensors ([Figure 1.3](#)) are considered as the Scan Fish design flaw, which leads to the appearance of VG\_prh-anomalies (anomalies due to roll-pitch of Scan Fish) on the magnetic field gradient recordings. Actually, VG\_prh-anomalies are noise generated by metal parts near the magnetic field sensor. The noise will be most severe in areas with relatively rugged terrain (e.g., sand wave zones), which will be enveloped by Scan Fish.

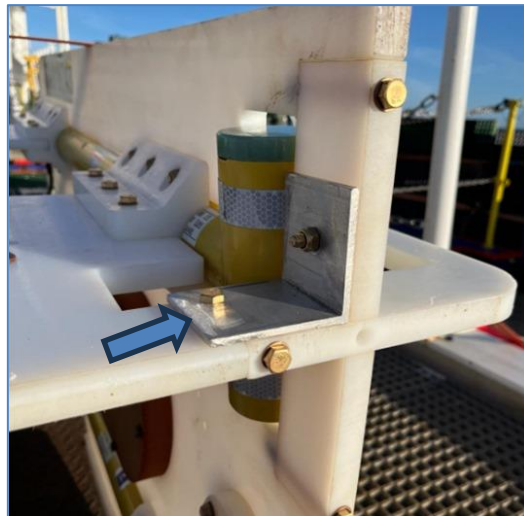
When installed in close proximity to the magnetic sensor aluminium structural elements, such as reinforcing plates, fasteners, frame elements, high-frequency noise appears on the magnetic field recordings. [Figure 2.1](#) shows a photo of the magnetometer frame reinforced with an aluminium plate. The plate itself is located in close proximity to the magnetic sensor.

[Figure 2.1](#) Positioning of the aluminium element next to the magnetic field sensor
